King Ranch Gas Plant - RADU Recovery Project

By: Barton W. Harris, P.E.

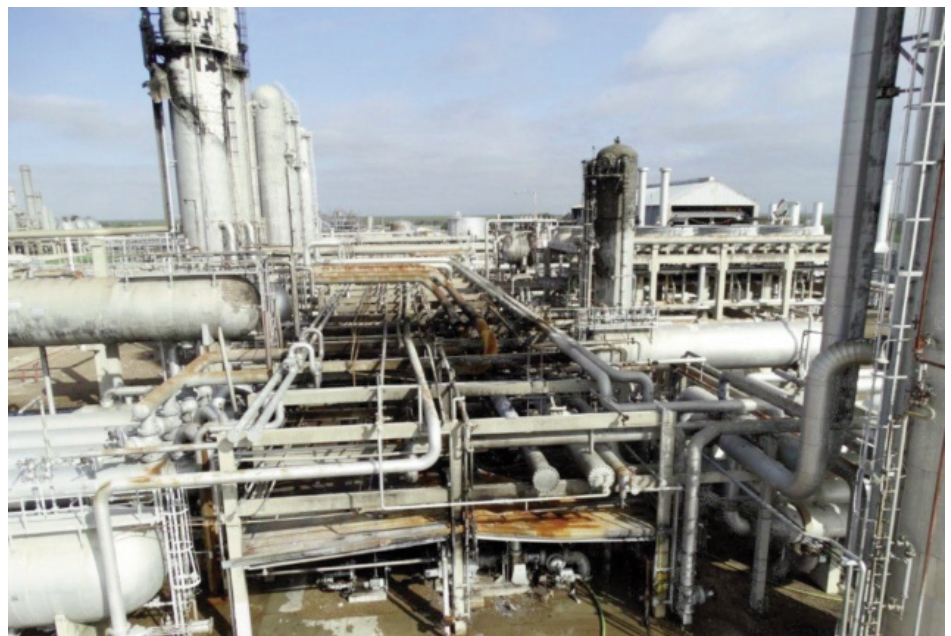
In mid-November 2013, a pump failure at ExxonMobil's King Ranch Gas Plant (KRGF) started a fire that damaged approximately one hundred feet of piperack in the Refrigeration and Demethanization Unit (RADU). The fire also caused damage to adjacent pumps, pipe racks, piping, and appurtenances on nearby process vessels. The fire was quickly contained and allowed to burn out; fortunately there were no injuries, which was a direct result of the prompt actions taken during its incipient stage.

Overview of Damaged Piperack - Looking North

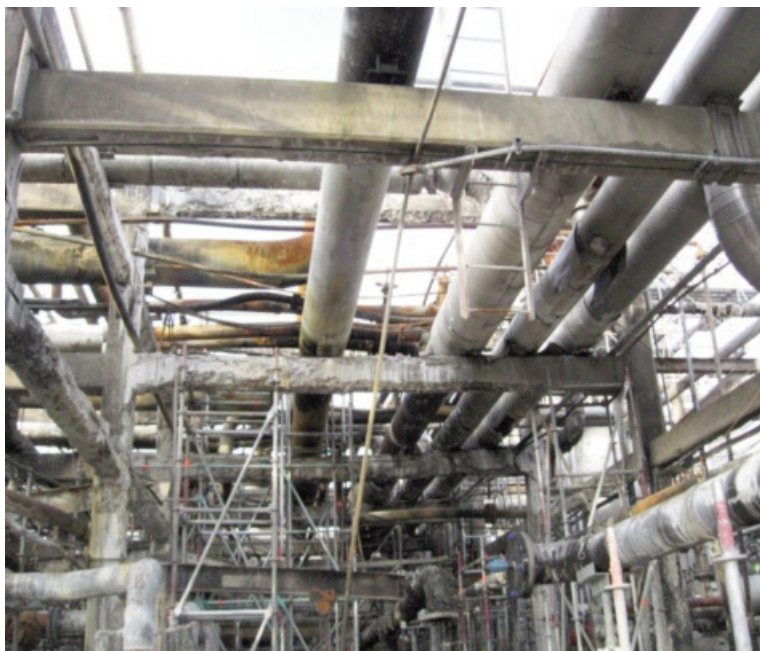
executed as soon as demolition was complete. The original RADU piperack was a space frame constructed from pre-cast components that were interconnected by field-welding the main reinforcing steel at the joints and then installing high strength grout to complete the connection and moment frames. The piperack columns were supported from drilled piers with a continuous moment connection constructed by the same means. It was actually quite impressive that the necessarily close tolerances were maintained in the concrete construction of the original facility.

Close-up View of Original Concrete Piperack Bent

resistant, it did not lend itself well to reconstruction on a fast-tracked schedule. After a quick study, it was determined that the most expedient rebuild approach would be to cut off the concrete piperack columns at the top of the drilled piers and then reconstruct the structure as a bolted steel moment frame with base plates bolted to the existing piers. Following erection, the new steel piperack would be fireproofed per current ExxonMobil specifications.

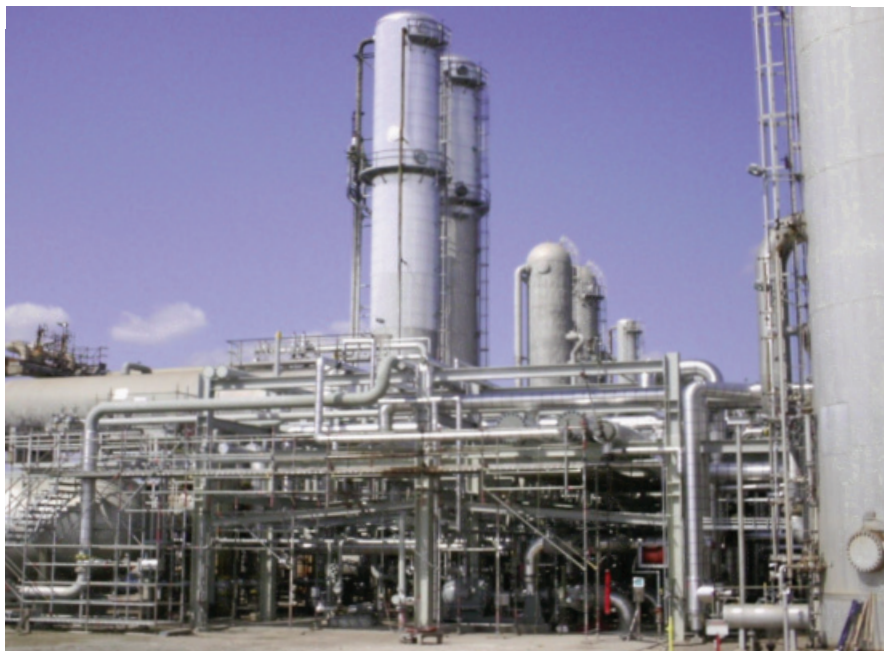
South End of Reconstructed Pipe Rack - Looking Northwest

bolted moment connections to facilitate quick erection with adequate tolerances. Sliding connections were provided at the interconnection to the existing piperacks to allow for horizontal movements while transferring vertical gravity loads. The existing concrete piperack is a stiffer structure than the new steel frames and the sliding connections were employed to avoid having the re-built piperack effectively laterally supported from the existing structure. Such an arrangement could lead to overloading of the existing frames and/or foundations.

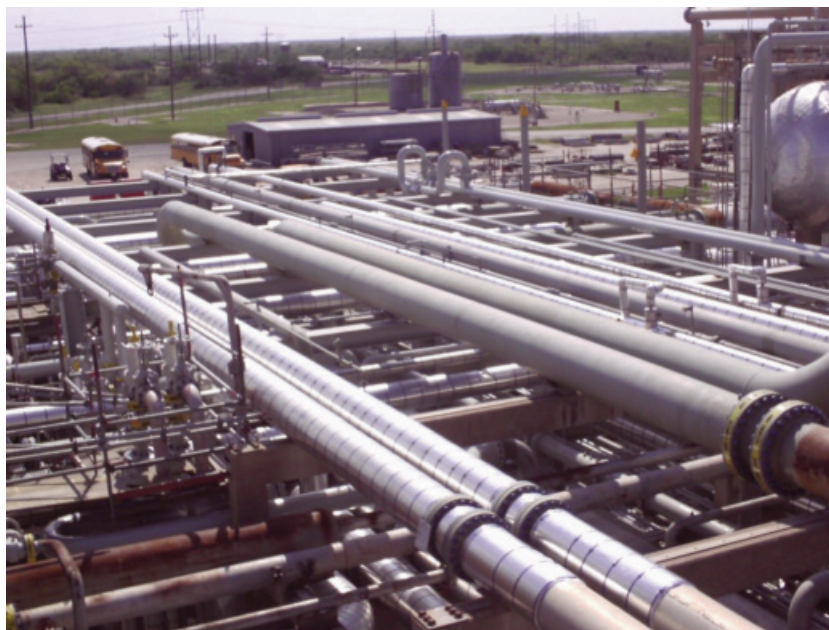
Upper Elevation of Reconstructed Piperack - Looking Southwest
