WALDEMAR S. NELSON AND COMPANY
INCORPORATED
ENGINEERS AND ARCHITECTS

Volume 55

3rd Quarter 2012

NELSON - Serving Southeast Louisiana with Hurricane Flood Control

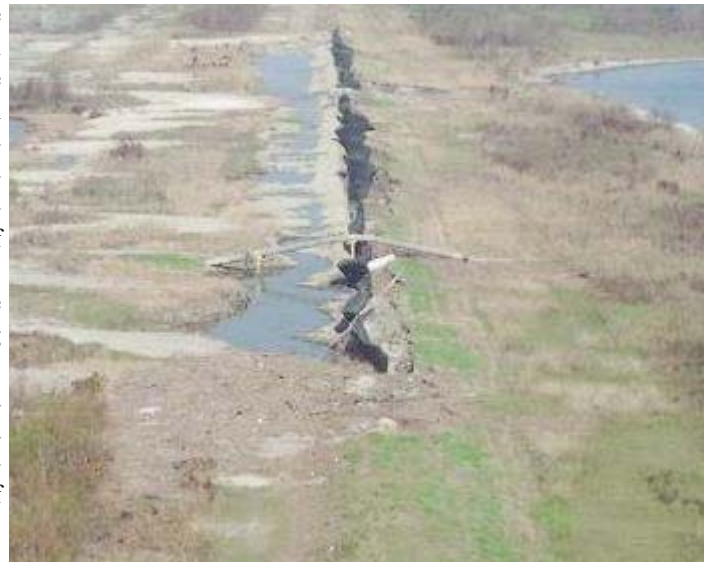
MRGO Overtopping Damage

determine the volume of levee material washed away by the storm surge. Based on this, NELSON developed plans and specifications for the reconstruction of 11 miles of levee along the MRGO and provided onsite inspection during levee reconstruction. NELSON provided inspection services and plans and specifications for the repair of floodwalls, floodgates, and flood control structures damaged by barge impact and storm surge overtopping.

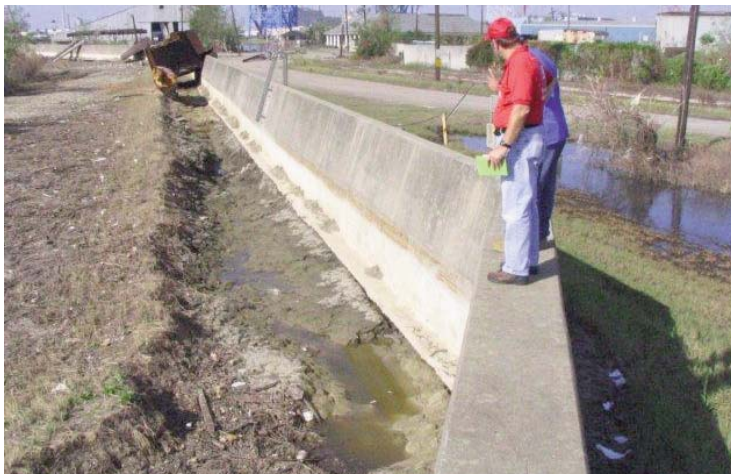
IHNC Floodwall Overtopping Damage

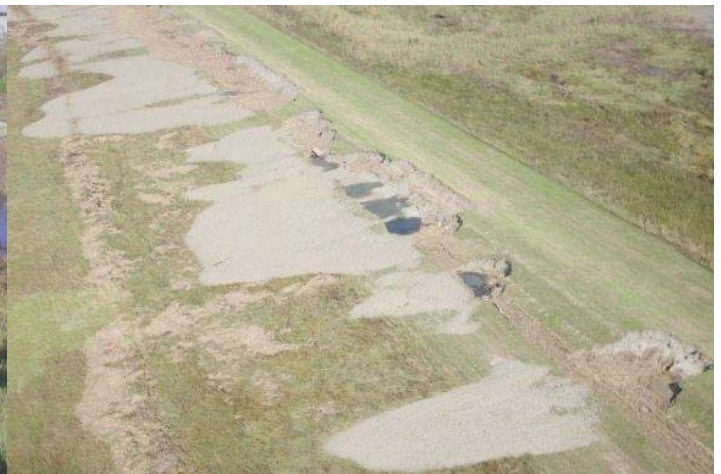
MRGO Levee Damage

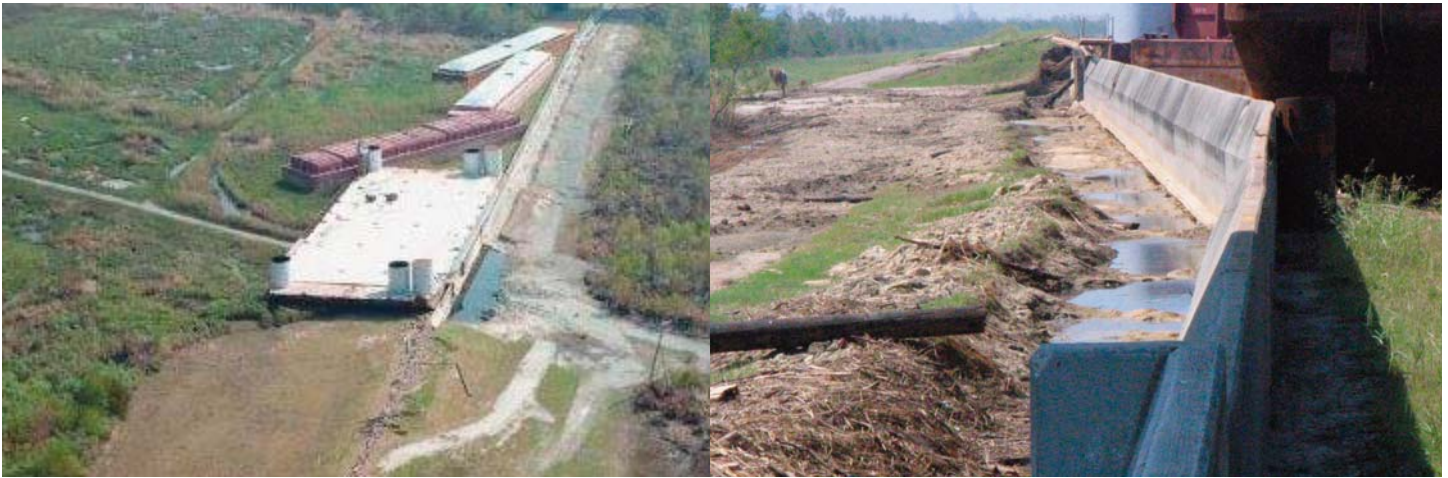
Barge Overtopping Damage to IHNC Floodwall and Levee

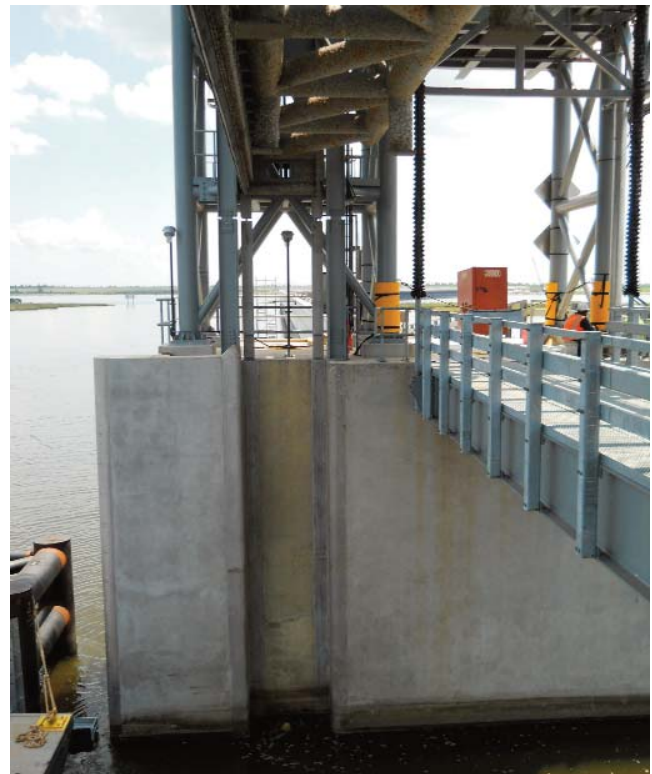
Lift Gate Slots and Access Bridge

Pedestrian and vehicular access across the channel is provided by a separate bridge on the protected side of the gate. The gate is

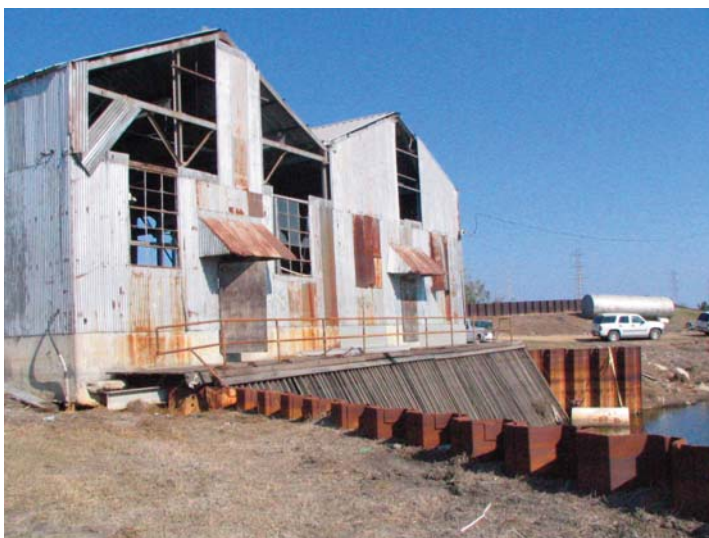
Pump Station Damage

NELSON inspected eight St. Bernard Parish pumping stations damaged by Katrina, provided reports of damage and

estimates for repair, developed conceptual designs as the basis of a design/build contract for repair of the three heavily-damaged stations, and provided onsite Quality

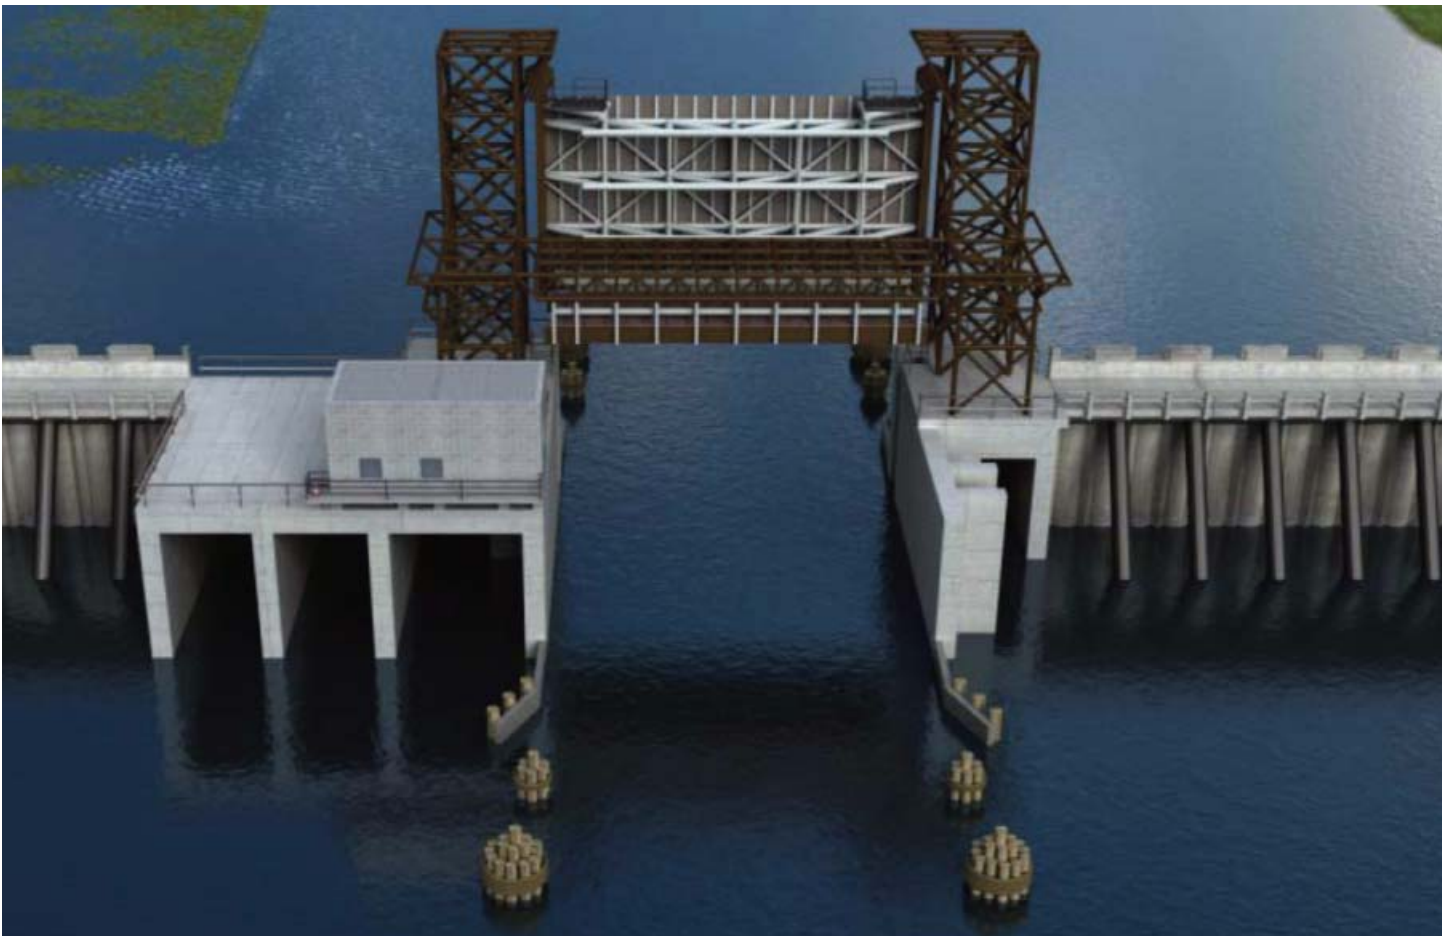
Bayou Bienvenue Lift Gate

Vertical support in the closed position is provided by four interior legs in the channel and four bearing plates at the base of the end posts. These 8 supports transfer the 140 ton weight to stainless steel plates embedded in the concrete monolith floor which is supported by a pile foundation. The bottom seal is compressed 1.5 inches when the gate is in the lowered position.

The Bayou Bienvenue Gate is lifted by cables using a winch and sheave system. Each end of the gate is supported by a single sheave. The gate is raised, lowered, and supported in the open position by sheaves attached to pad-eyes that are attached to the top of the gate end posts and secured to the sheaves with pins. Each sheave is supported by two independent cables. If one of

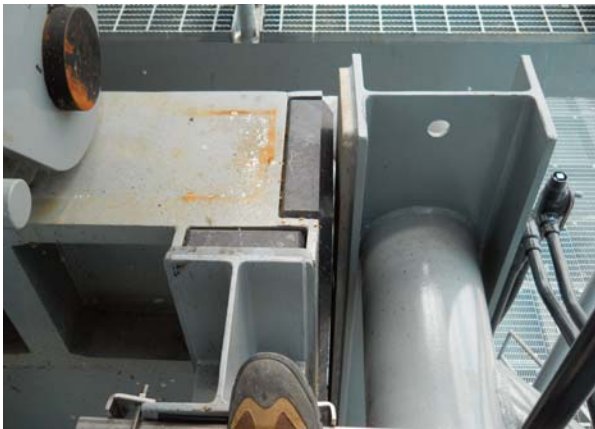
Half Inch Clearance

provide horizontal support to the gate. Precise fabrication tolerances were required due to the project's requirements of a maximum allowable clearance of $\frac{1}{2}$ inch between the UHMW pads and the stainless steel plates.

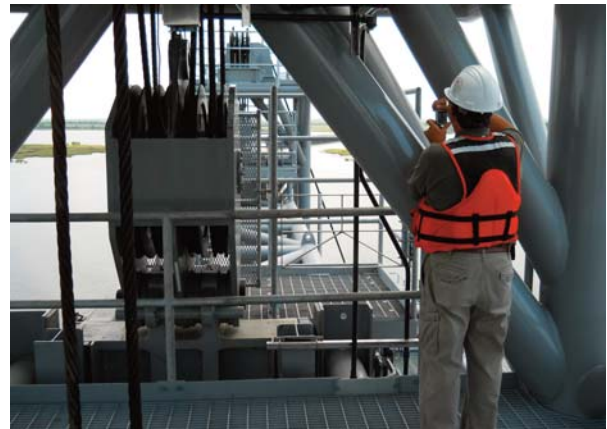
Support Sheave

the four cables fails, the remaining three cables can support, raise, or lower the gate without overstress. Vertical support for the gate is provided by the cables in all positions except the lowered position.

Maintenance platforms are provided for inspection and maintenance of each sheave. Access to the platforms is from the monolith with the gate in the down position or from an access platform in the support tower with the gate in the raised position. During design it was discovered that the resulting slamming forces from wave overtopping on the gate would destroy any reasonably sized walkway. Therefore it was decided that no walkway would be provided to connect the two maintenance platforms.

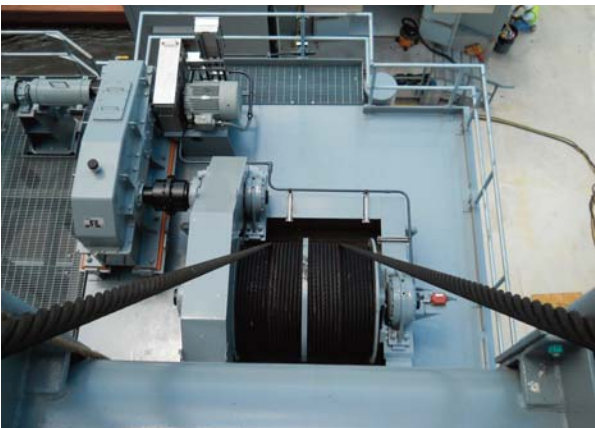
Lift Cables and Winch

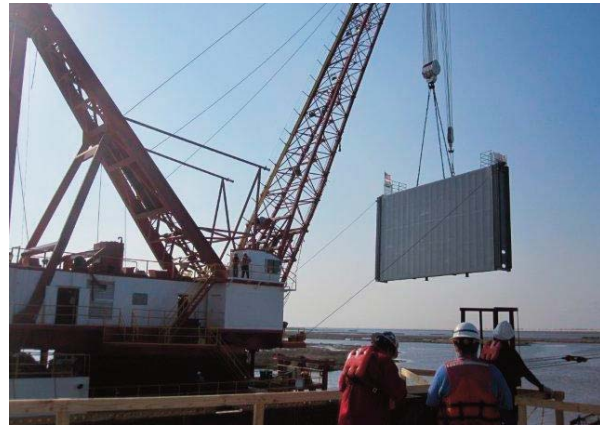
Gate Installation

provided with 3 pad-eyes for use during installation.

In March 2011, prior to construction of the lift towers, the lift gate was installed in the closed position. Once the gate was installed, the Bayou Bienvenue structure attained 100-year level of hurricane risk reduction. The towers were completed a year later and Bayou Bienvenue was opened to boat traffic. It remained in the open position until the approach of Hurricane Isaac when it was lowered and provided risk reduction to St. Bernard Parish, New Orleans' Lower 9th Ward, and New Orleans East. It is again in the lifted position, none the worse for wear, ready to battle the next storm.

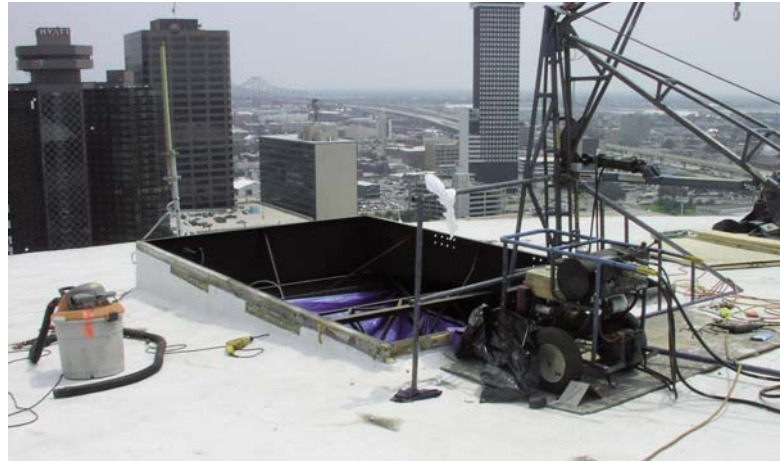
Superdome Roof

In addition to the repairs of damages to our levees, floodwalls, and pumping stations caused by Hurricane Katrina, NELSON was also quick to respond to Superdome roof damage by Katrina when the push was on to be ready for the Saints 2006 season return. When it was determined that the damaged roof vents could not be replaced in-kind, NELSON engineering was quickly on the Superdome roof to design supporting frames to match the new vents.
